San Nicolas Slope Restoration Monitoring

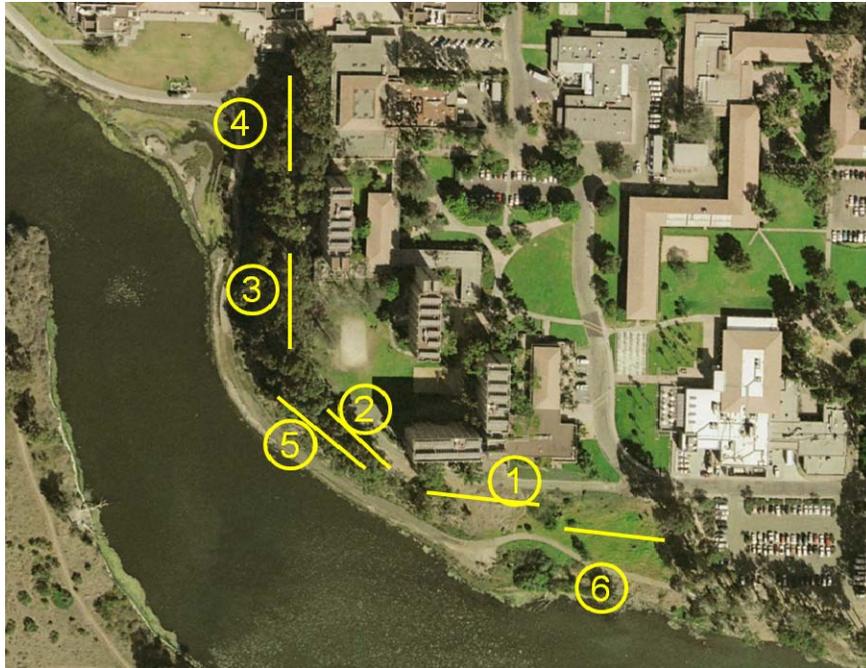
Figure 1: Transect locations on San Nicolas Slope.

Annual Monitoring surveys of San Nicolas Slope began in 2007. There are six monitoring transects that span the length of the slope. Transects 1 through 4 are located on the upper portion of the slope, transect five is on the lower part of the slope alongside the road, and transect six, which was added in 2009, spans the area of the site that was covered in Kikuyu grass.

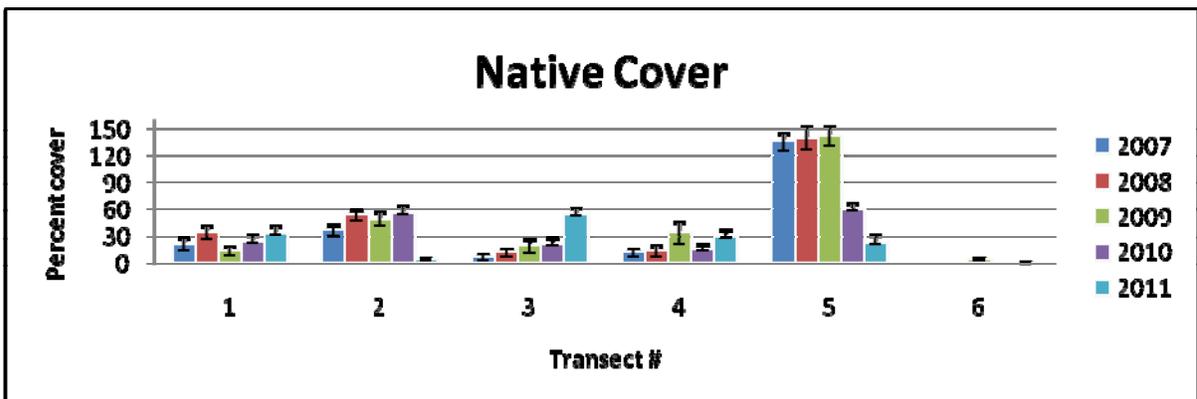
Transects 1,2 ,3 , and 4 were planted in 2007 and 2008. Establishment in transects 3 and 4 was very low due to the effects of the Eucalyptus leaf litter from the overhanging canopy. Transect 2 had significantly higher establishment than transects 3 and 4 which is most likely because there was very little Eucalyptus overhanging this area. While transect one had no Eucalyptus cover, native establishment is still fairly low due to competition with abundant non-native weeds in such as radish and kikuyu grass.

Chart 1: Percent native cover at San Nicolas Slope from 2007 to 2011.

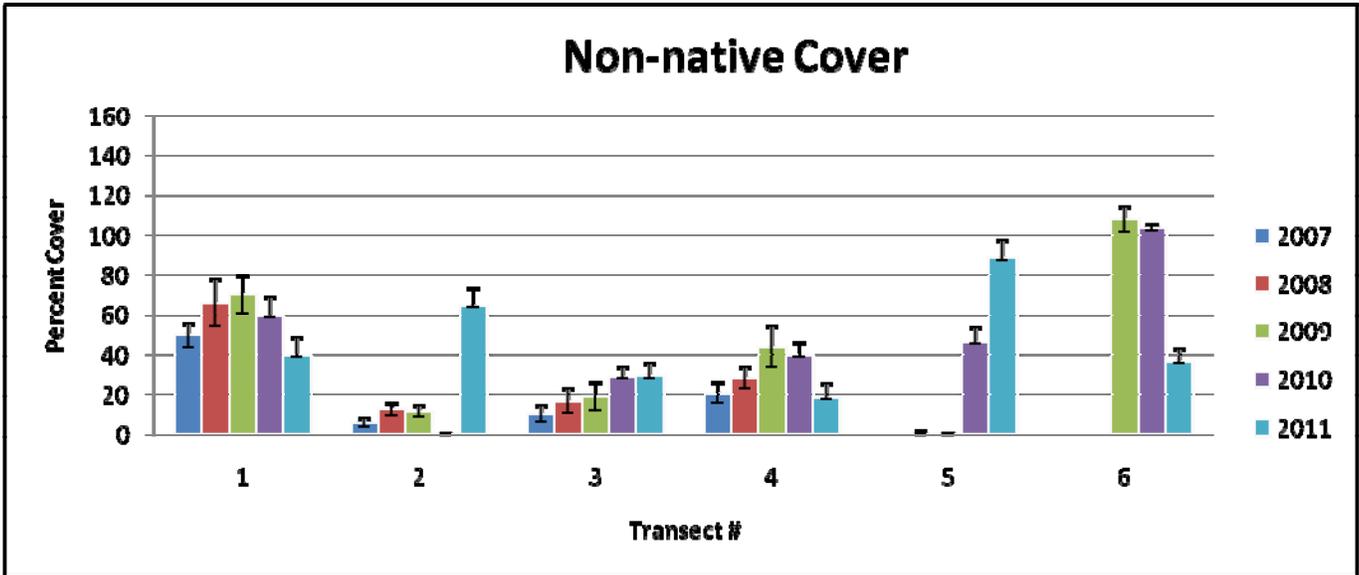
Transect six was added in 2009 to gather baseline data for this area of the site. The 2009 data shows that transect six is completely covered in non-native Kikuyu grass, while in 2011 there large bare ground component reflects that the weeds have been cleared from the site.

Chart 2: Percent non-native cover at San Nicolas Slope from 2007 to 2011.

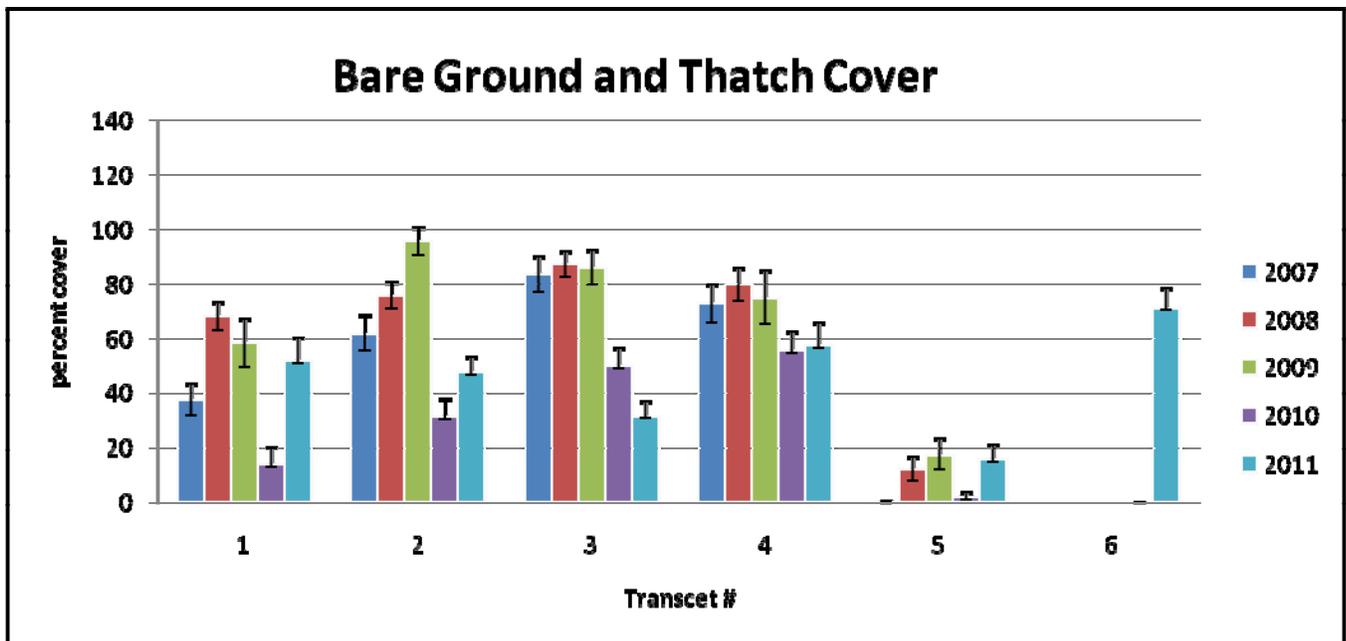
Bare ground and thatch cover is very high in sites 2, 3, and 4 due to the abundant litter inputs from the overhanging Eucalyptus. Transect 1 has a lot of woody thatch in the form previous years dried radish stems and branches. Transect 6 was newly planted at the time of monitoring and has high bare ground cover and open water where the wetland was created.

Chart 3: Percent bare ground and thatch cover at San Nicolas Slope from 2007 to 2011.

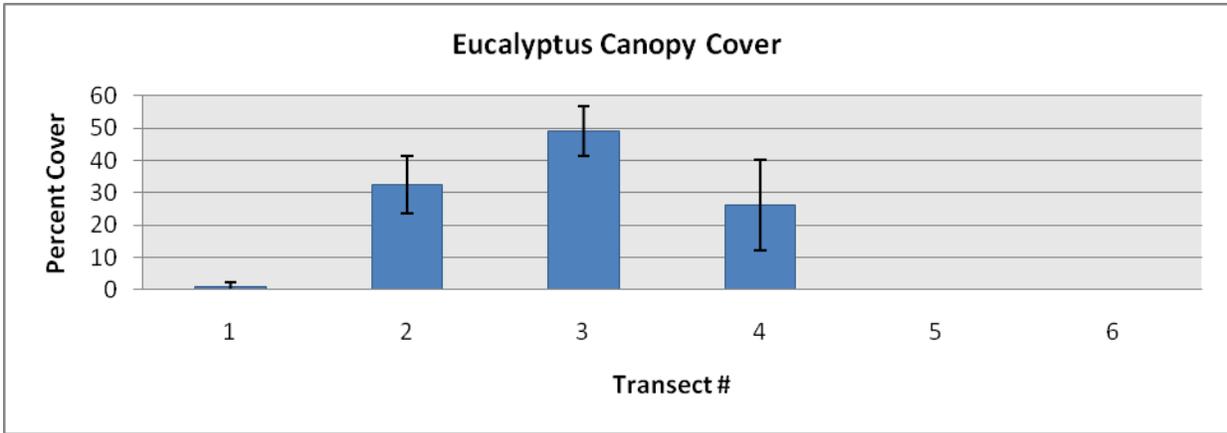
Chart 4: Percent Eucalyptus canopy cover at San Nicolas Slope in 2009.

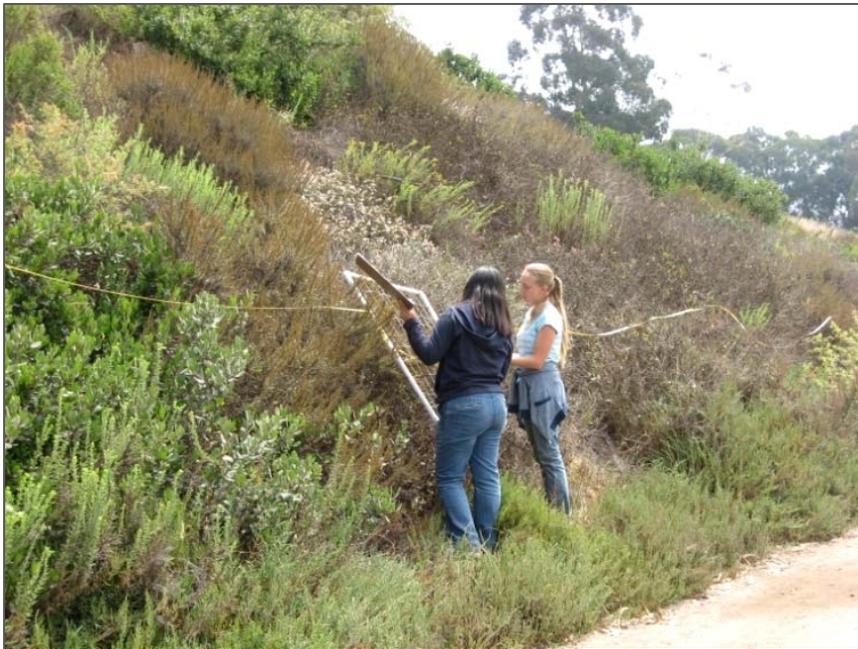
Transect five has an extremely high native cover while non-natives are nearly absent. The vegetation in this transect was planted between 1995 and 1998; thus it is very well established. Furthermore, there is no Eucalyptus canopy above this transect so plant growth is not suppressed by the leaf litter.

Figure 2: The native vegetation across transect five is well established at nearly 100 percent cover.

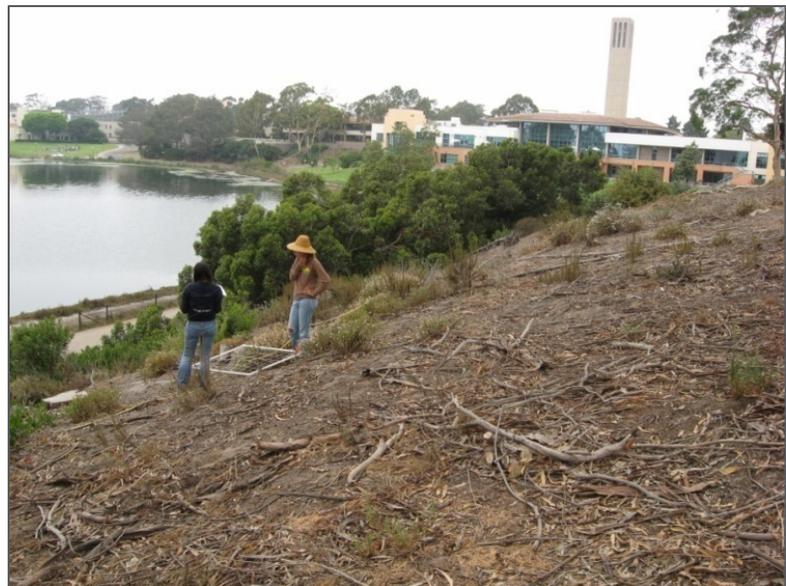
Figure 3: Establishment of natives across transect three was very low due the effects of Eucalyptus litter.
